United States Department of Agriculture
Agricultural Research Administration
Bureau of Entomology and Plant Quarantine

+ INSTALLATION OF WINDOWS IN PANELS OF A SEDAN DELIVERY TRUCK
U. S. DEPARTMENT OF AGRICULTURE

By O. E. Berndt

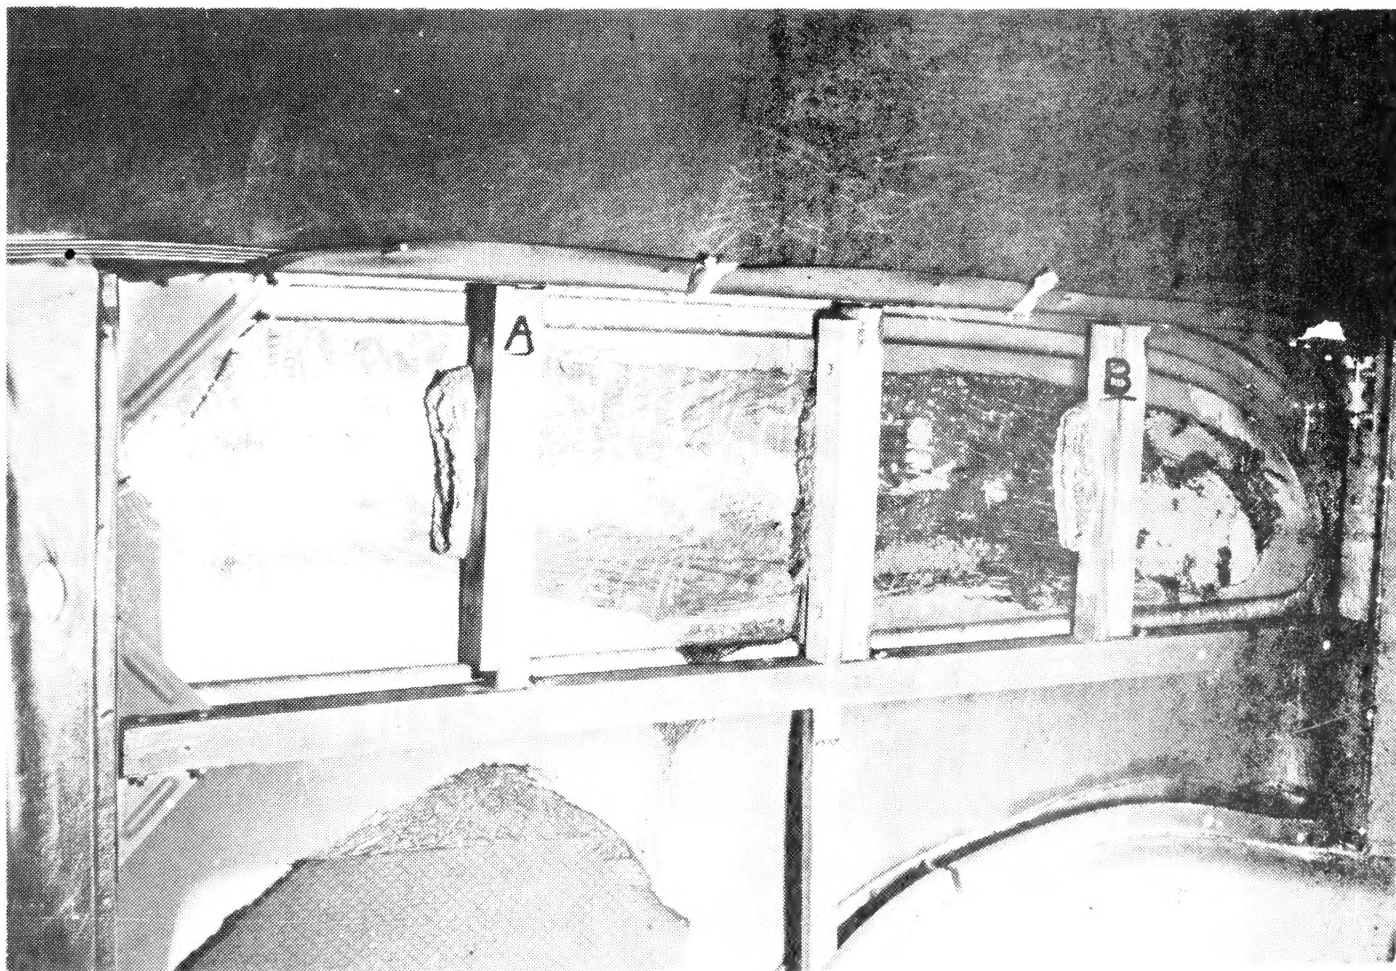
Figure 1.--Interior view of truck showing fiberboard removed, exposing side wall bracing. Struts A and B are removed to permit window installation.

The inside fiberboard wall covering the framework of the car is first removed to expose the bracing members as installed at the factory. The two struts A and B in figure 1, lateral of the center strut, are then removed.

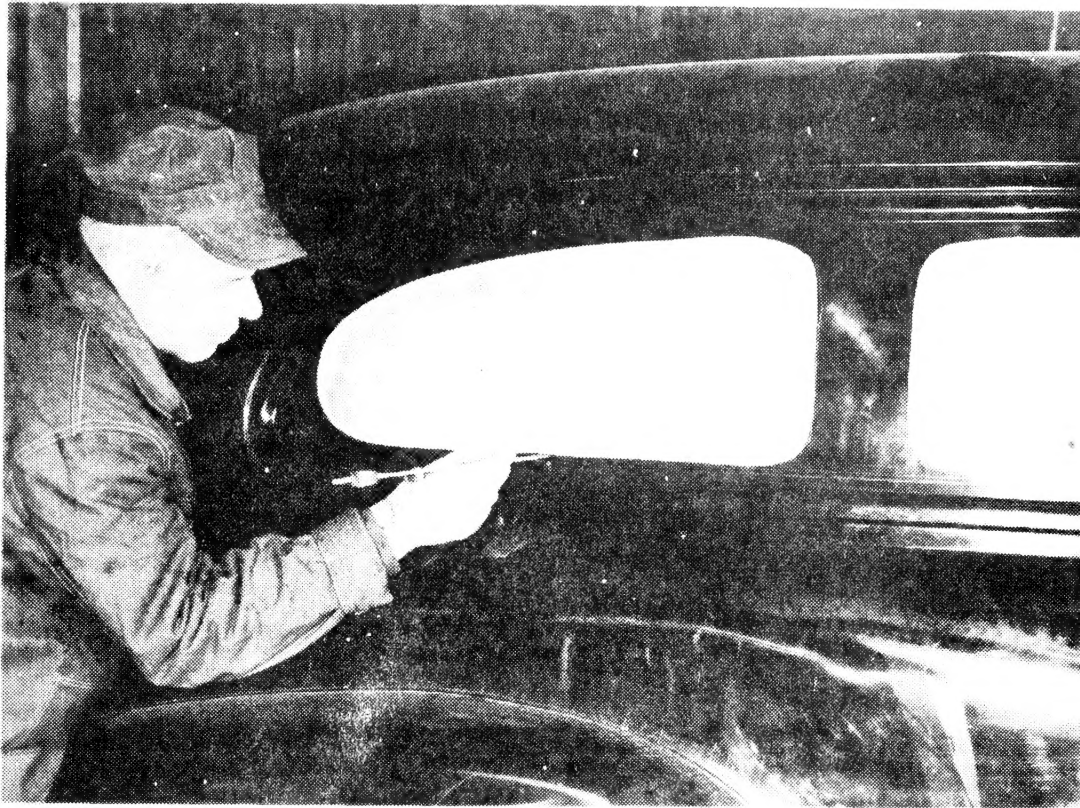
Figure 2.—Exterior view of truck, showing paper template attached to panel surface. Scribe is drawn around edge of template to mark cutting line.

A paper template is made and pasted on the outside surface of the panel in the position in which the windows are to be cut. The template follows as nearly as practical the contours of the panel. A 1-inch margin was left between the edge of the template and the edge of the panel in the truck illustrated. If the panels are larger, a wider margin is allowed in the interest of proper proportioning, appearance and strength. With the template in place, a scribe is used to mark the line of the cut on the metal surface (fig. 2).

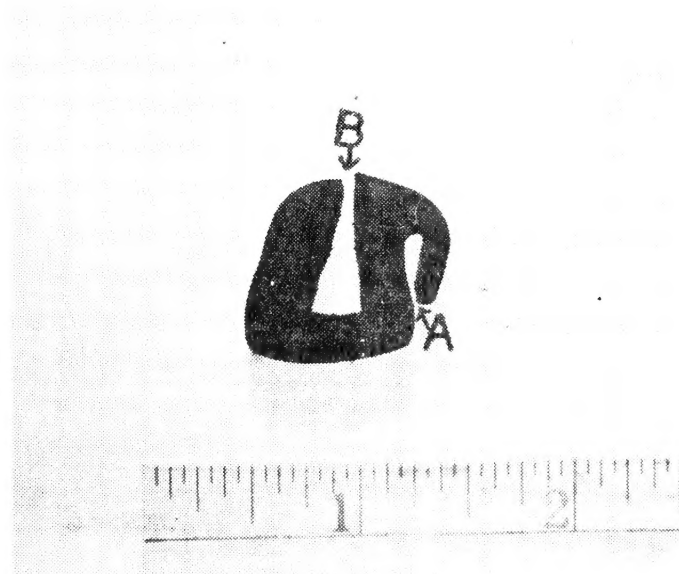
Figure 3.—Cross section of channel rubber, showing grooves in which glass and metal are imbedded.

A strip of channel rubber similar to that commonly used in installing automobile windows is worked over the cut edge of the metal with a screw driver or a similar tool, so that the narrow groove in the rubber fits over the metal edge (fig. 3-A). The rubber strip is cut so that a tight butt joint is made at the top of the window. This joint is later sealed with liquid rubber and sanded until it is practically invisible.

The rubber is then removed and fitted over a glass pane cut to a size $\frac{1}{4}$ inch larger all around than the opening into which it is to be fitted. The pane with its periphery imbedded in the wide groove (fig. 3-B) of the channel rubber is then inserted in the opening with the overlap of the pane on the inside of the panel.

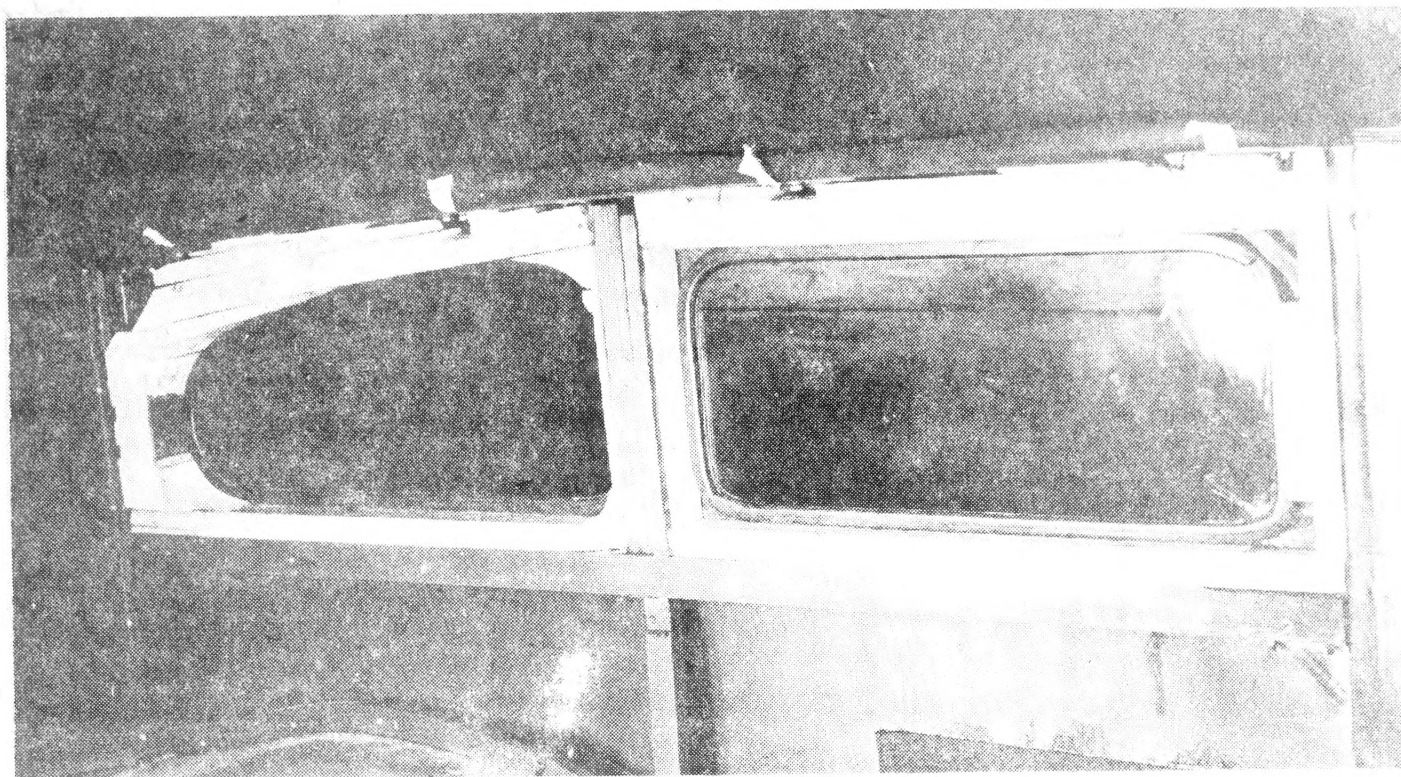
Figure 4.--New casing around rubber on inside of panel to replace bracing and provide solid backing for tacking fiberboard wall and trimming at window sill.

When the pane is in place, the framework of the window is formed with wood pieces fashioned to conform to the contours of the window, and attached solidly with nails and screws to the remaining original supporting framework (fig. 4). The curved corners can be installed most easily by use of short metal strips. A strip of a neutral shade of standard-gage linoleum is fastened to the new framework with small box nails and cut to a width equal to the thickness of the frame (fig. 5). The inside fiberboard wall is then attached in its original position, and the window openings are cut to correspond exactly with the edges of the linoleum strip on the window framework.

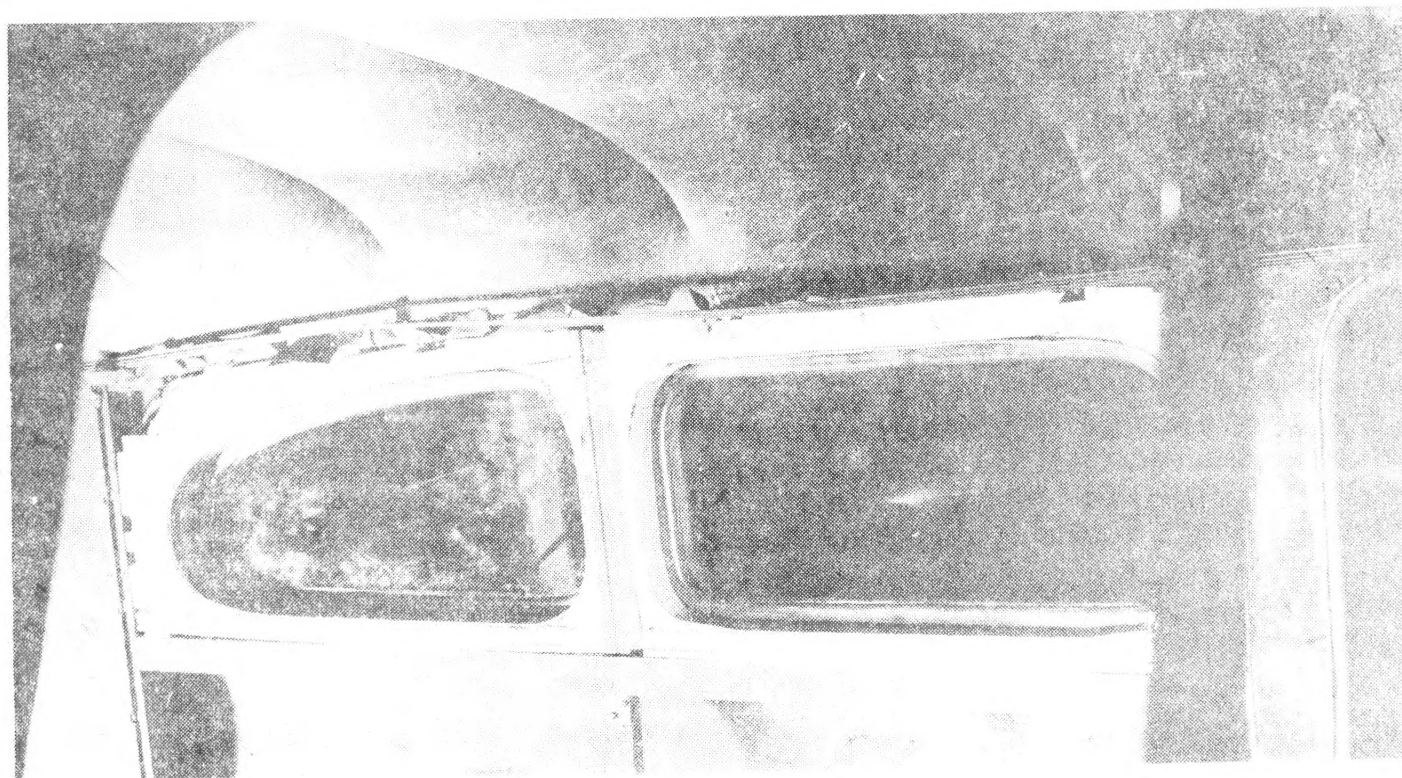
Figure 5.--Completed interior installation, showing casing and linoleum strip in place prior to replacing fiberboard wall.

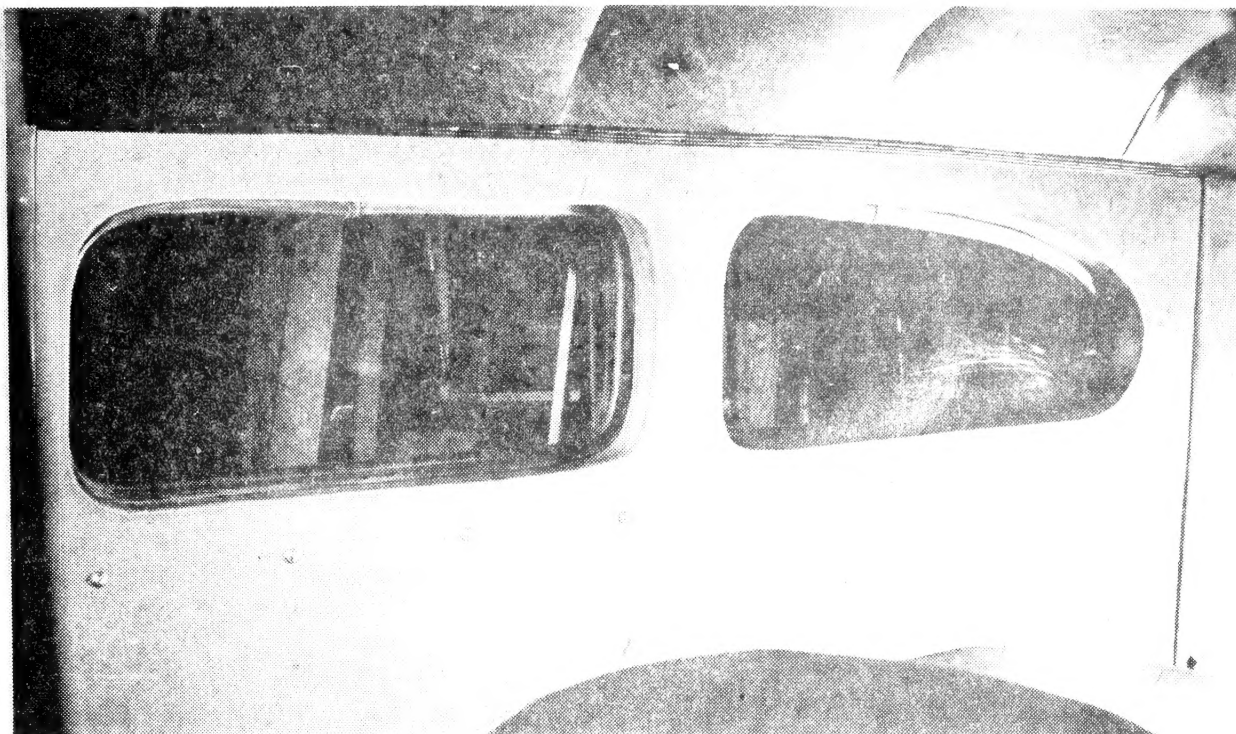
Figure 6.--Interior view showing completed job with fiberboard wall in place and window opening trimmed to sill.

An interior view of the finished job is shown in figure 6, and the exterior appearance of the car with the windows installed is shown in figure 7.

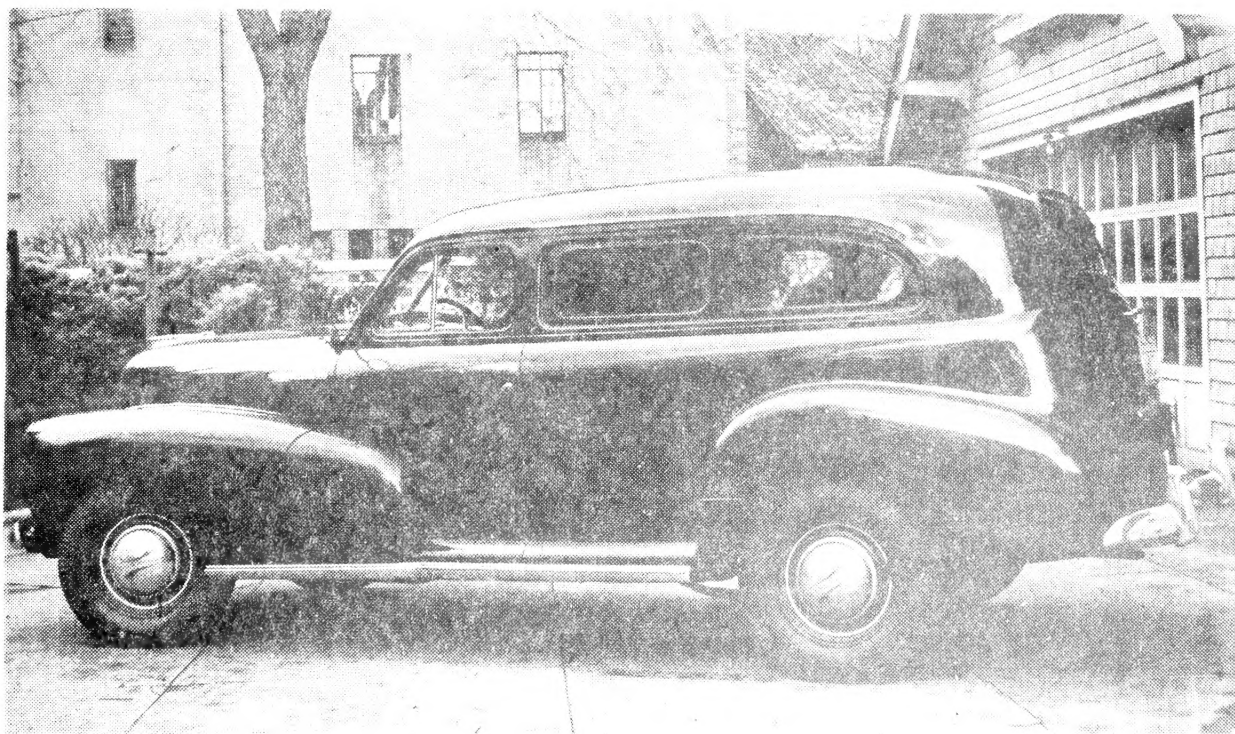
Figure 7.--Exterior view of truck with window installation completed.
